REPORT OF INVESTIGATION
(UNDERGROUND COAL MINE)

FATAL OUTBURST OF COAL ACCIDENT

No. 21 mine (ID No. 46-05801)
W-P Coal Company
Stirrat, Logan County, West Virginia

November 29, 1983

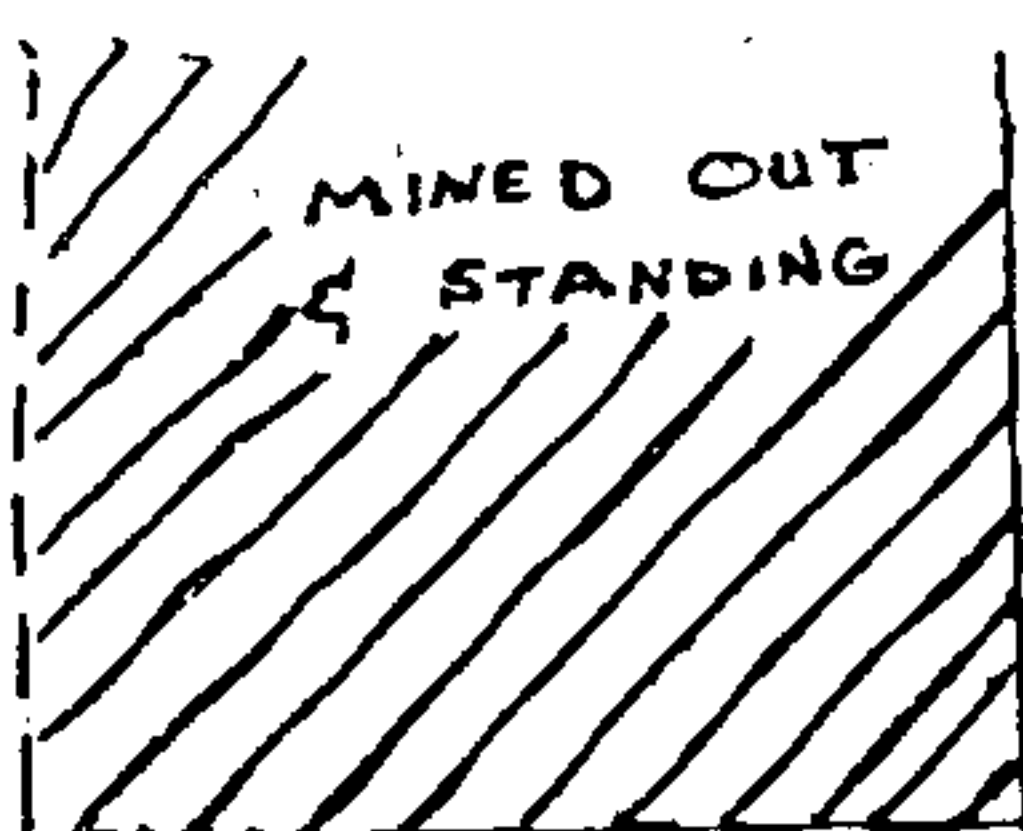
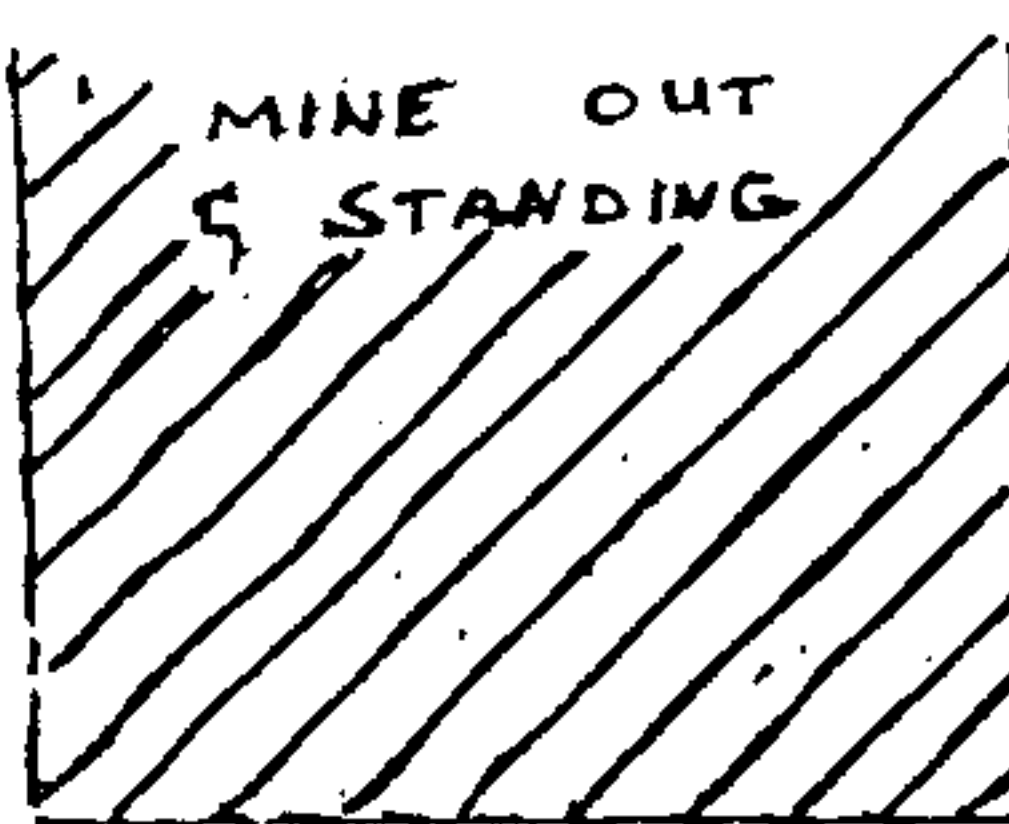
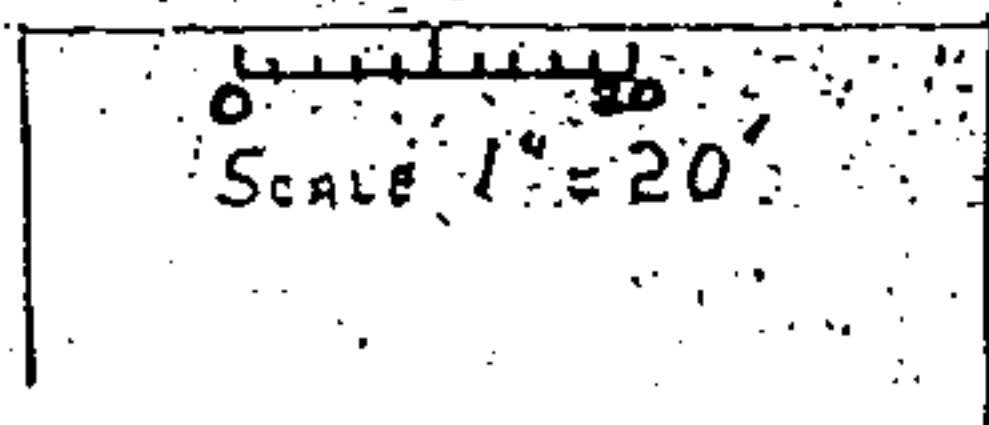
Sketch No. 1

Fatal Outburst of Coal
4 South Section
No. 21 mine (ID No. 46-05801)
W-P Coal Company
November 29, 1983

Bircher then proceeded to the No. 4 pillar block where he found Mounts and Sias. Mounts was located in the crosscut and to the left of the roof bolting machine. He appeared to be suffering from shock with no visual injuries. Sias (victim) was found with his head against the front of the roof bolting machine. Sias received serious head injuries.

6. The Lee-Norse continuous mining machine, model No. 245-10-7E, serial No. 8567, which was cutting the face of No. 5 pillar block when the outburst occurred was moved by the force about 15 feet outby the working face. The continuous mining machine measured 33 feet long, 10½ feet wide, 24 inches high, and weighed about 26½ tons. The 3-inch thick ripperhead support arms were cracked; the two

brackets holding the ripperhead jacks were broken; the two gathering head hinge pins were broken; the left ripperhead motor support bracket was broken; the bolts used to mount the contactor control panel located in the operator's compartment were broken; portions of the hydraulic fittings were broken off the valve chest located in the operator's deck; and the boom conveyor was cracked on both sides.
